Thermal Coating Repairs for Marine Applications

Job: Seaspan Marine ULC - September 2013

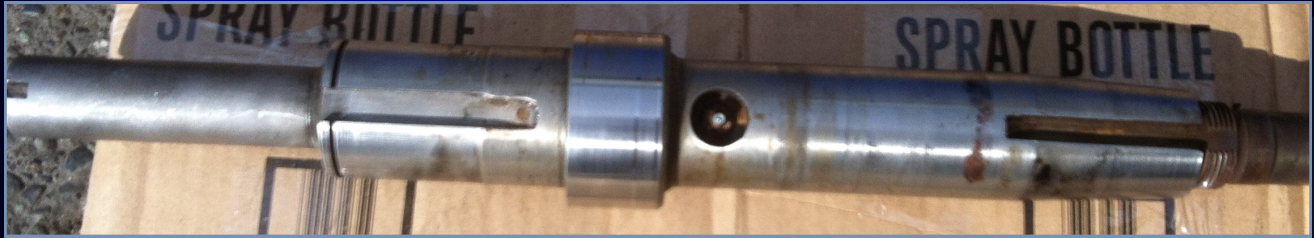
(Above) A marine input pump shaft with a worn bearing fit over the keyway

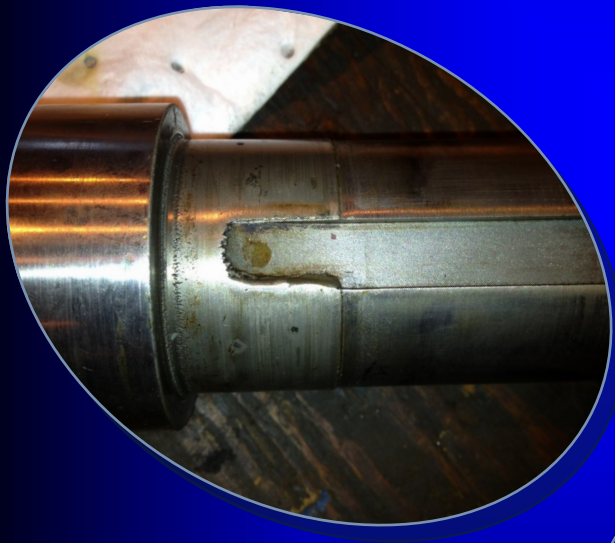
(Left) Before Repair: A close up of the area to be rebuilt. Bearing sits partially over the key way area.
