## Evolution of an industry

# High-tech repair options for ship repairs

By Dale Finnerty  
Industrial Surface Technologies Inc.

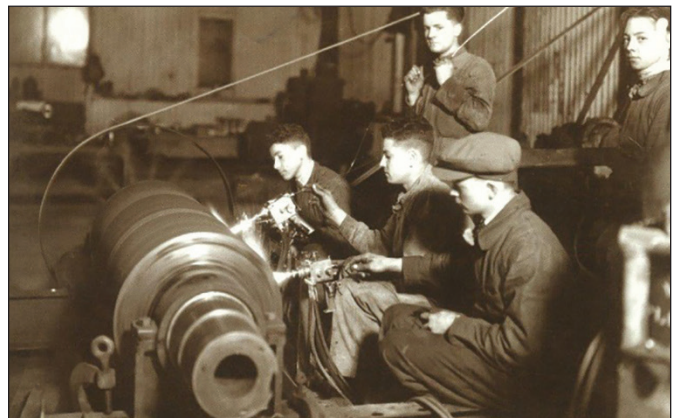
*The old days — problems with temperatures, alloy quality and bonding made early thermal coatings an unattractive solution to most repairs.*

While the old technology of thermal coating was once plagued by problems, new advances and continual improvements in equipment, product quality, and training have completely revamped the process. There were many factors that caused

problems in applying coatings in earlier days — temperatures, alloy quality and bonding ability to name a few. Consequently there were failures and bad experiences that gave the industry a bad rap. Today, the equipment and application methods are quite amazing when done properly. In fact, 40 per cent of the global thermal spray market is based on the aerospace (turbine) market, where the consequences of reliability is measured in human life. They would not be using thermal spray coatings if there was any risk of failure.

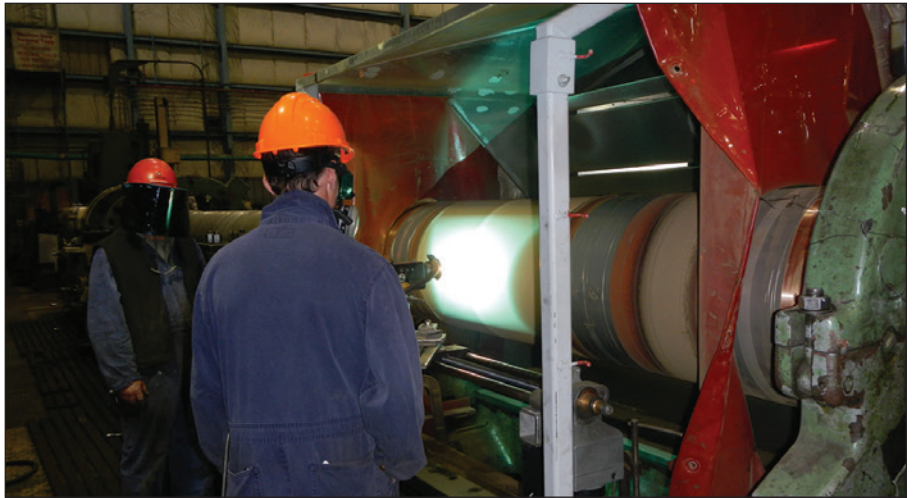
*Advances in thermal coating processes means repairs to components like tail shafts can be done quicker than re-manufacturing and will extend the life of the repair.*

While thermal coating has been a common remedy for many years for repairs of heavy equipment in industries such as mining, logging and construction, one local B.C. company has brought the technology to the marine industry and is catching the attention of those ship owners looking to extend the life of repairs on tail shafts, liners, housings, drive components and many other metal alloy components in their vessels.
